PAVEMENT RESEARCH
at the
WASHINGTON STATE UNIVERSITY
TEST TRACK

EXPERIMENTAL RING NO. 3: A STUDY OF UNTREATED,
EMULSION TREATED, AND ASPHALTIC-CEMENT TREATED BASES

Report to the Washington State Department of Highways
on Research Project Y-993

Highway Research Section
College of Engineering Research Division
Washington State University
Pullman, Washington
July, 1969

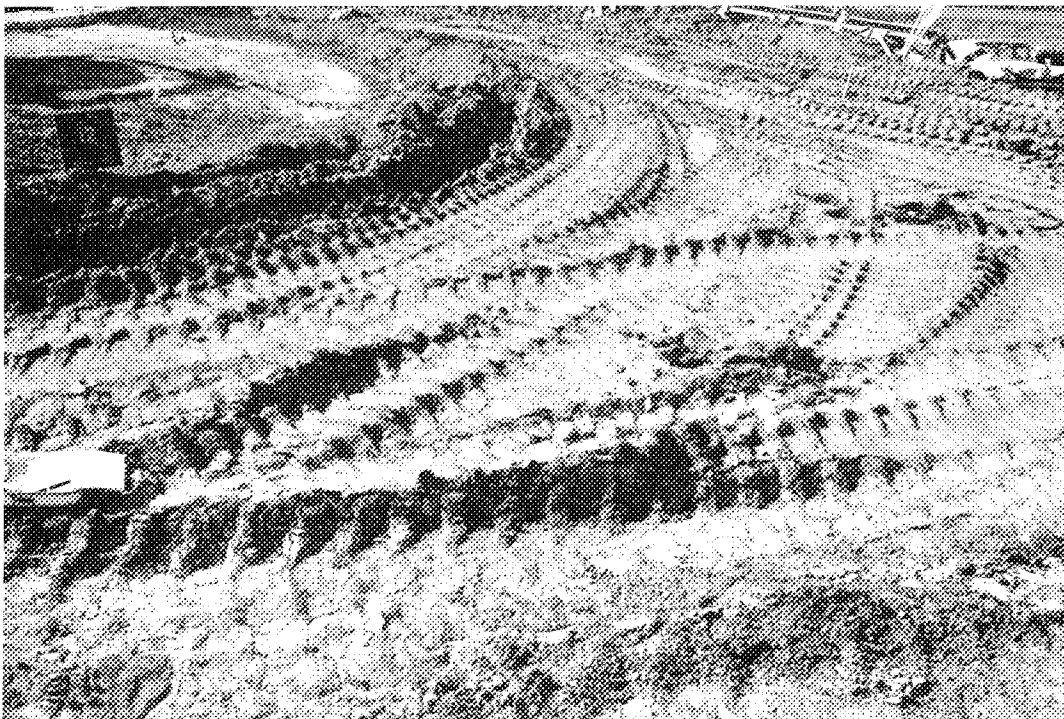
FIGURE 10. THIS SHOWS THE APPEARANCE OF THE SUBGRADE AFTER RING #2 PAVEMENT WAS REMOVED. NOTE THE TIRE TRACKS INDICATING THE SATURATED CONDITION OF THE PALOUSE SILT.

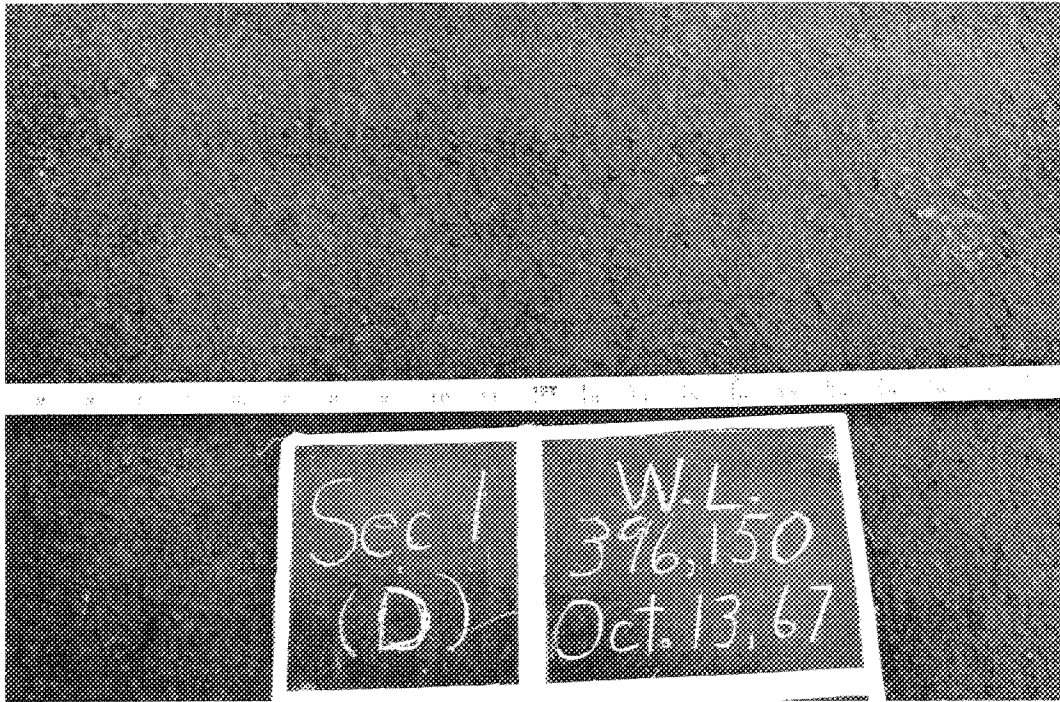
FIGURE 20. THE START OF TRANSVERSE CRACKS IN SECTION 1 (NO BASE) AFTER 396,150 WHEEL LOADS ON LINE D--OCTOBER 13, 1967.

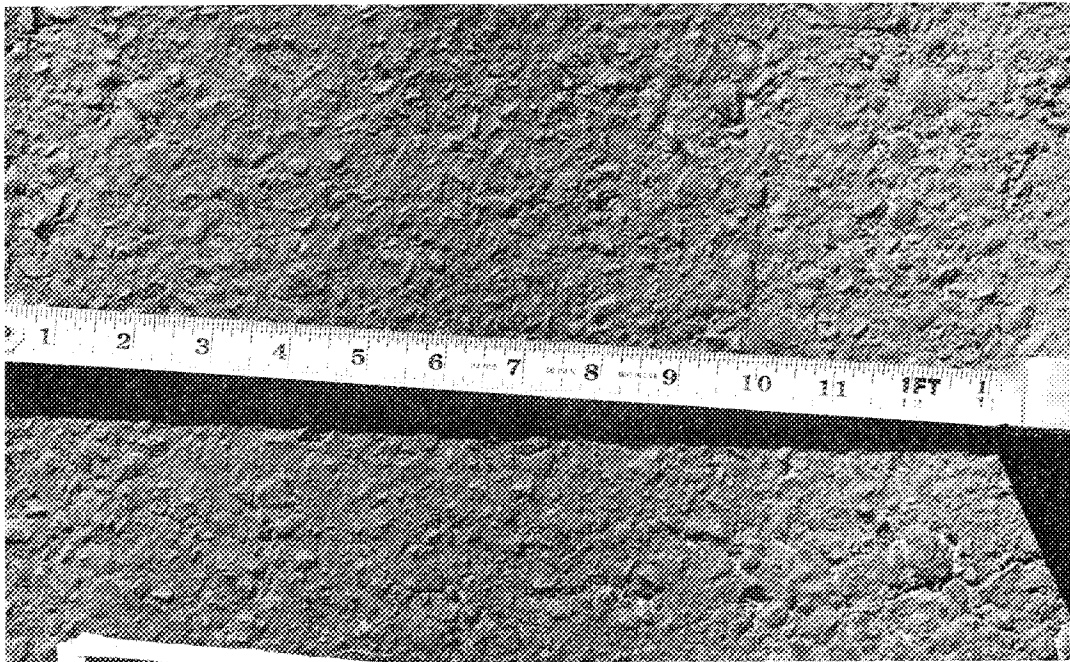
FIGURE 21. APPEARANCE OF SECTION 1 AFTER 562,335 WHEEL LOADS--OCTOBER 26, 1967.

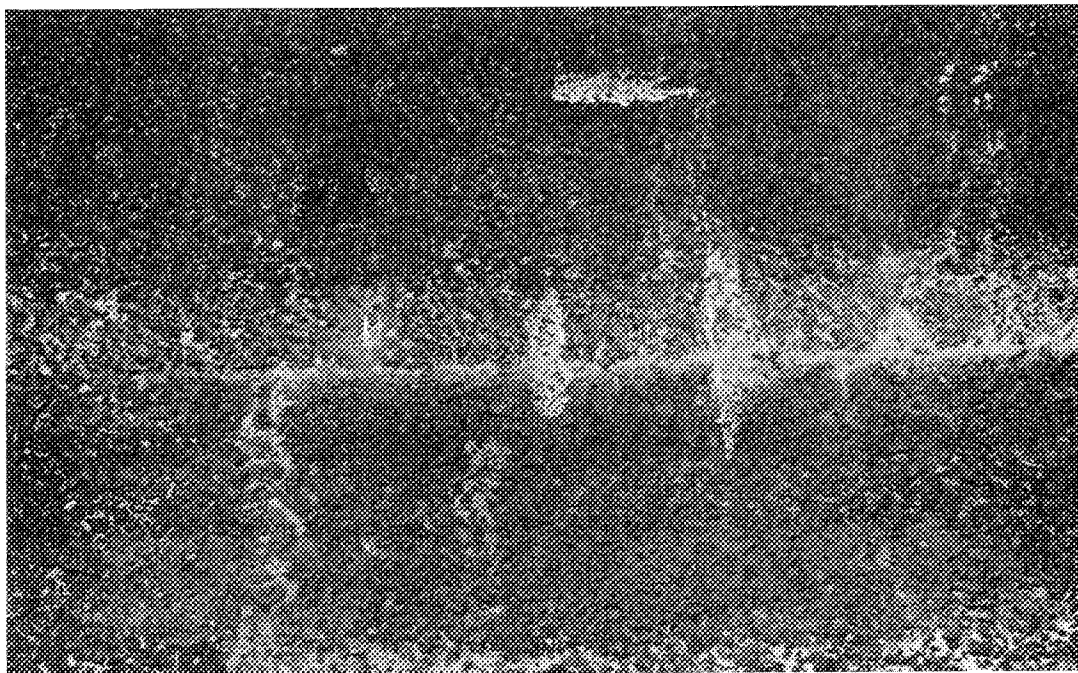
FIGURE 23. CONTINUED DETERIORATION OF SECTION 1 AFTER 588,000 WHEEL LOADS ON OCTOBER 30, 1967. NOTE THE INCREASED FREQUENCY OF TRANSVERSE CRACKS.

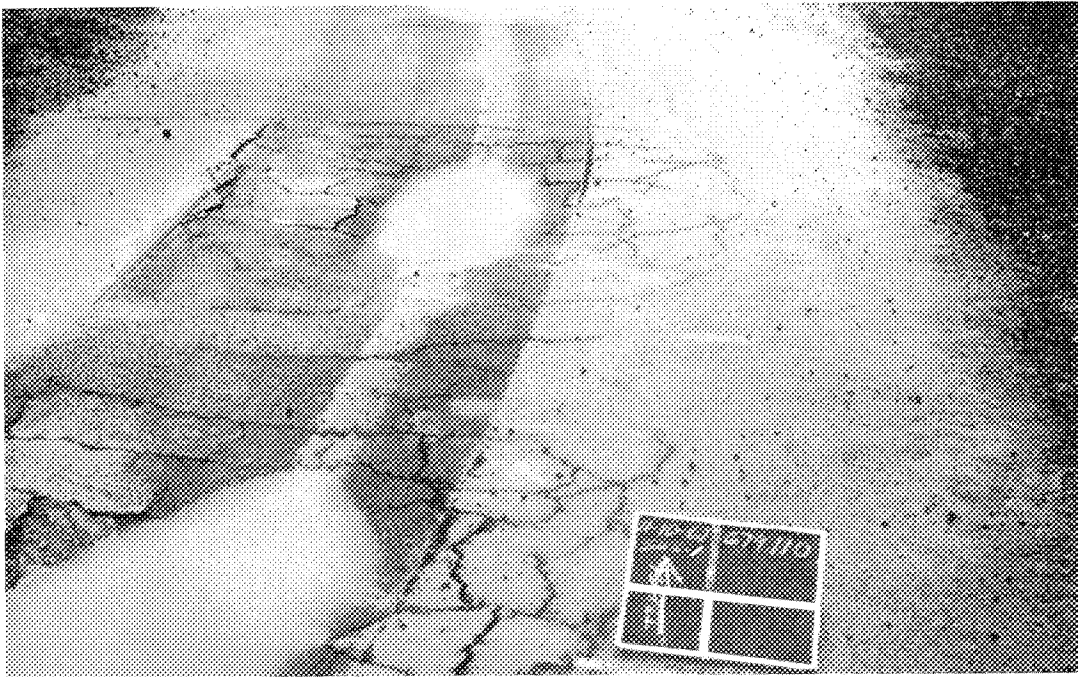
FIGURE 24. APPEARANCE OF SECTION 1 AFTER "ULTIMATE" FAILURE AND 679,107 WHEEL LOAD REPETITIONS ON NOVEMBER 10, 1967. THIS SECTION WAS REMOVED AND REPLACED WITH 8 INCHES OF ASPHALT CONCRETE.

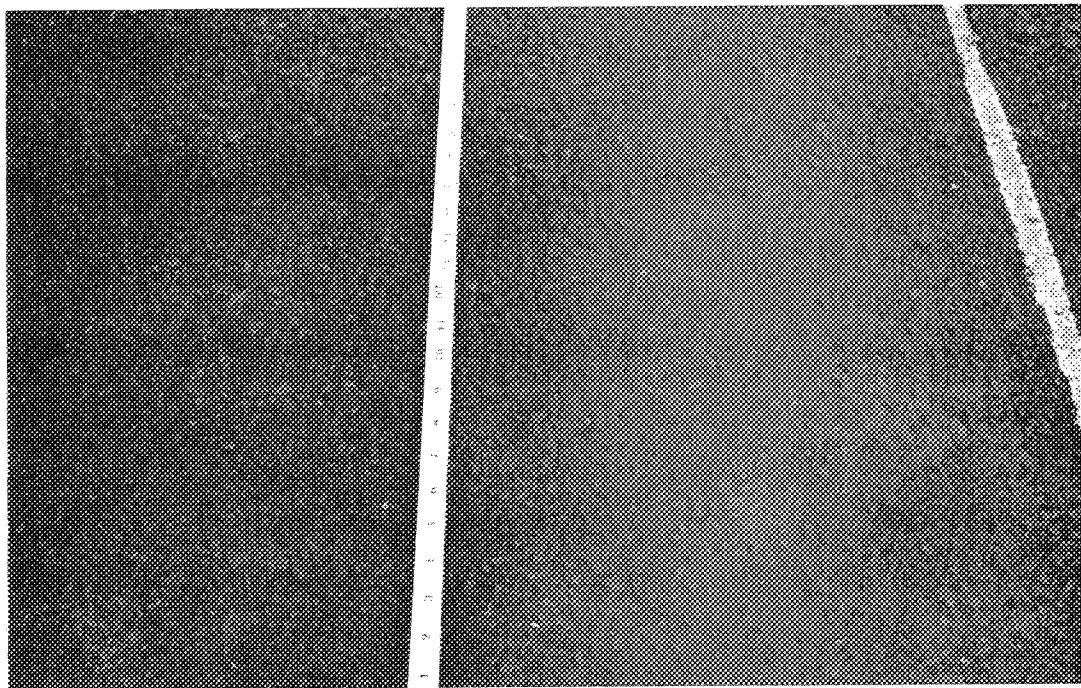
FIGURE 25. THE START OF TRANSVERSE CRACKS IN SECTION 6 (7.0 INCHES OF UNTREATED BASE) AFTER 396,150 WHEEL LOADS ON LINE A, OCTOBER 13, 1967.

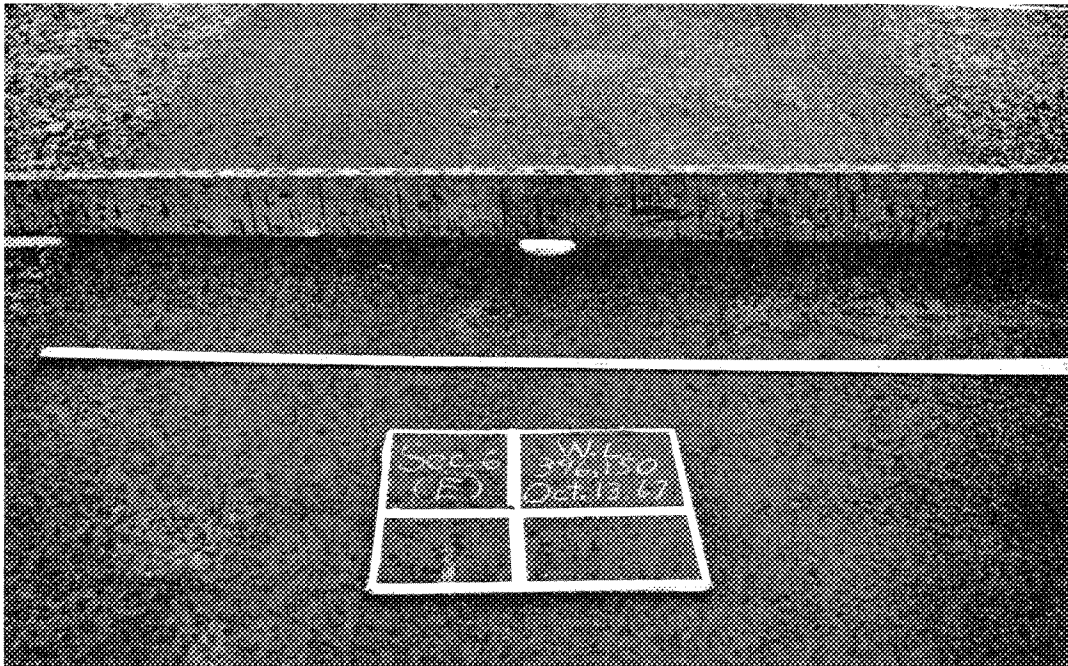
FIGURE 26. PERMANENT SETTLEMENT OF PAVEMENT IN SECTION 6 ON LINE E AFTER 396,150 WHEEL LOAD REPETITIONS.

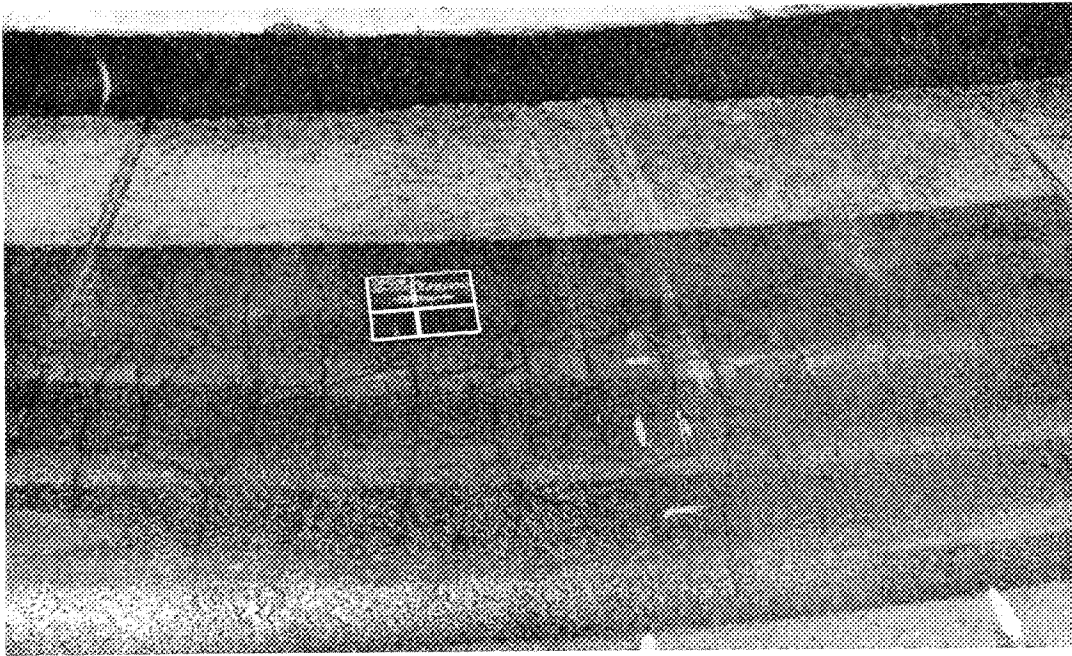
FIGURE 28. CONTINUED DETERIORATION OF SECTION 6 AFTER 588,000 WHEEL LOADS ON OCTOBER 30, 1967. NOTE THE UNIFORM "LARGE" ALLIGATOR CRACKING PATTERN.

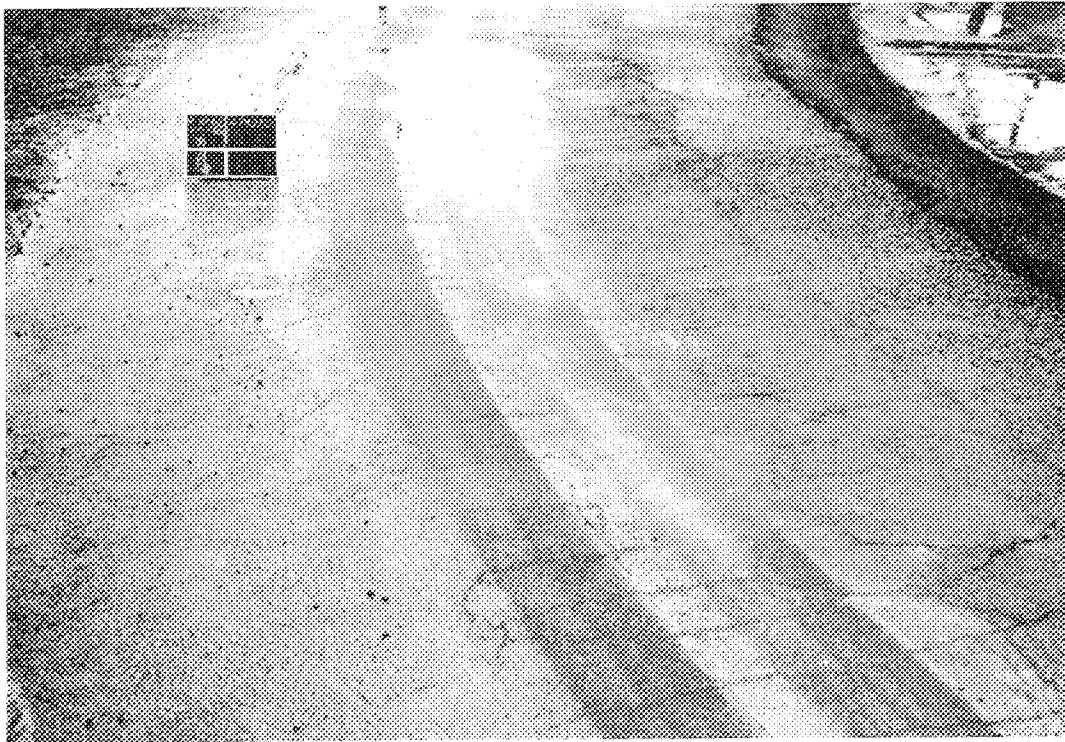
FIGURE 29. "ULTIMATE" FAILURE IN SECTION 6 AFTER 679,107 WHEEL LOADS ON NOVEMBER 10, 1967. NOTE LONGITUDINAL CRACKS AT BOTH WHEEL PATH EDGES, THE UNIFORM ALLIGATOR CRACKING PATTERN AND THE WATER IN THE CENTER.

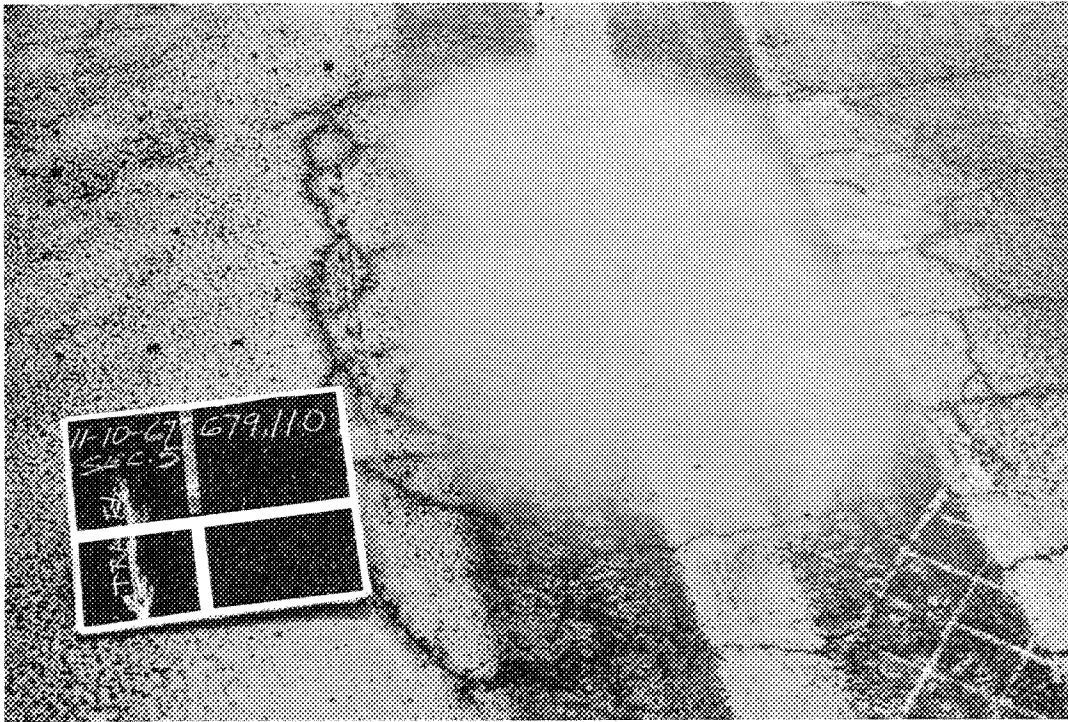
FIGURE 30. THE APPEARANCE OF SECTION 5 (4.5 INCHES OF UNTREATED BASE) AT "ULTIMATE" FAILURE AT 679,107 WHEEL LOAD REPETITIONS. THIS WAS LOCALIZED AROUND LINES E AND D.

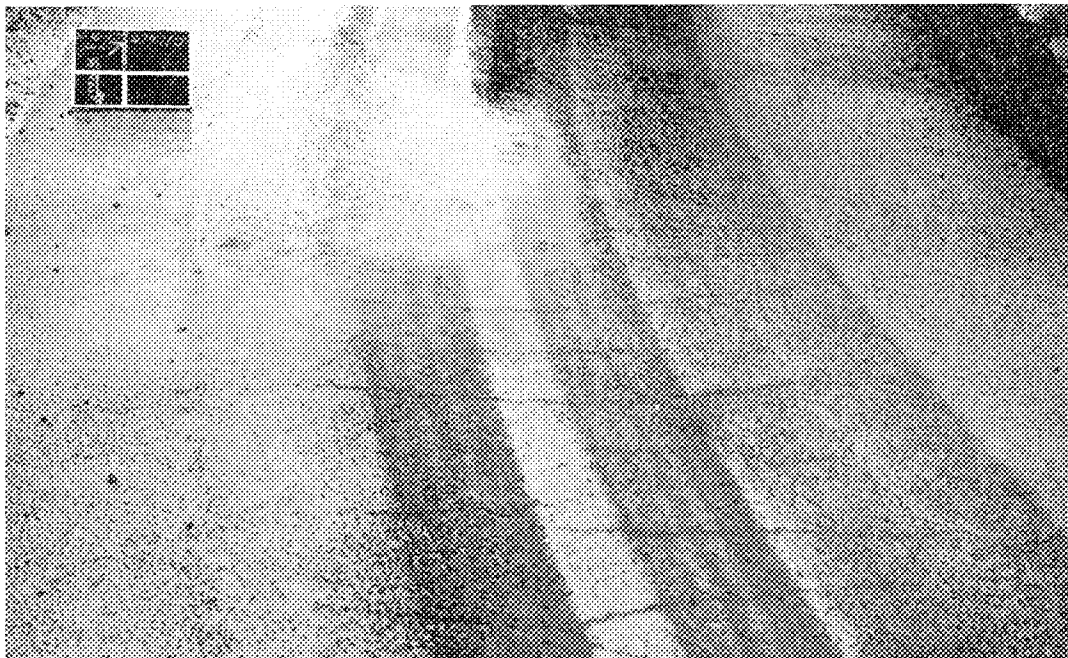
FIGURE 31. APPEARANCE AND FAILURE IN THE TRANSITION ZONE BETWEEN SECTIONS 6 AND 7 (9.5 INCHES OF UTB) AFTER 679,107 WHEEL LOAD REPETITIONS. AN ASPHALT OVERLAY WAS PUT OVER THIS AREA.

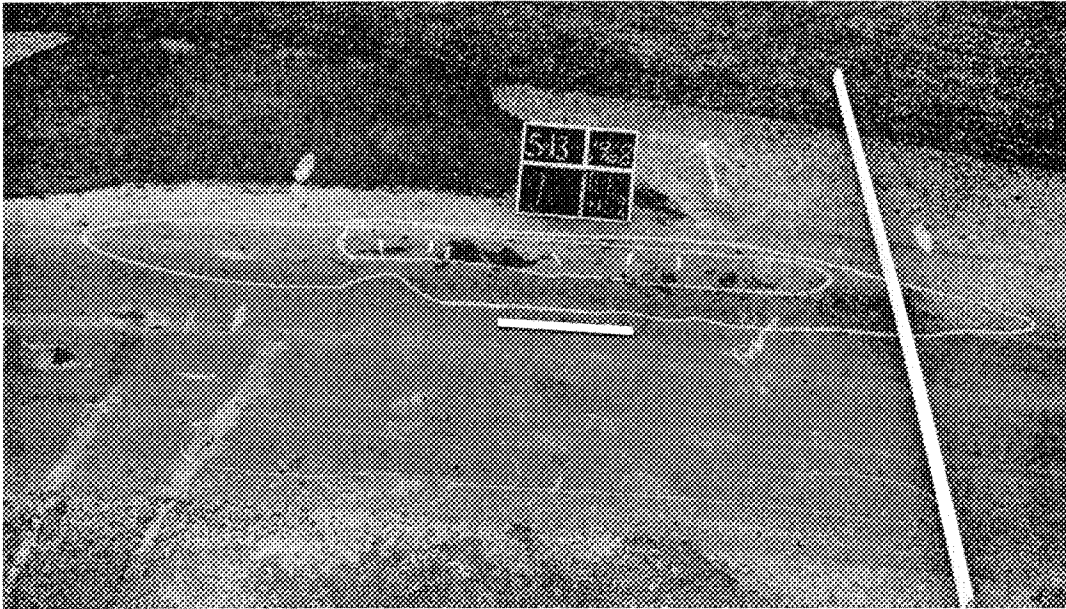
FIGURE 32. THE START OF FAILURE IN SECTION 9 (3.5 INCHES OF ETB) AFTER 736,896 WHEEL LOAD REPETITIONS. NOTE THE START OF LONGITUDINAL SHEAR CRACKS ALONG THE EDGE OF WHEEL PATH. THE INNER CHALK OUTLINED AREA WAS MARKED EARLIER AT 736,737 WHEEL LOADS ON MAY 13, 1968.

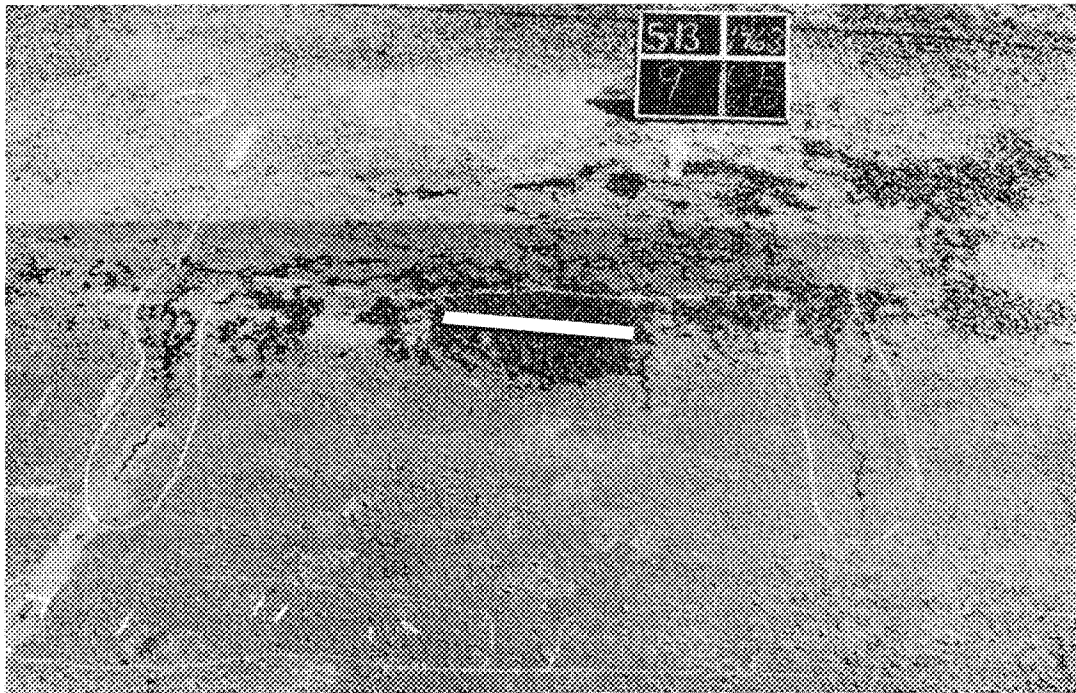
FIGURE 33. APPEARANCE OF SECTION 9 AFTER 737,587 WHEEL LOAD APPLICATIONS. NOTE THE TRANSVERSE CRACKS AND THE PERMANENT SETTLEMENT, MAY 13, 1968.

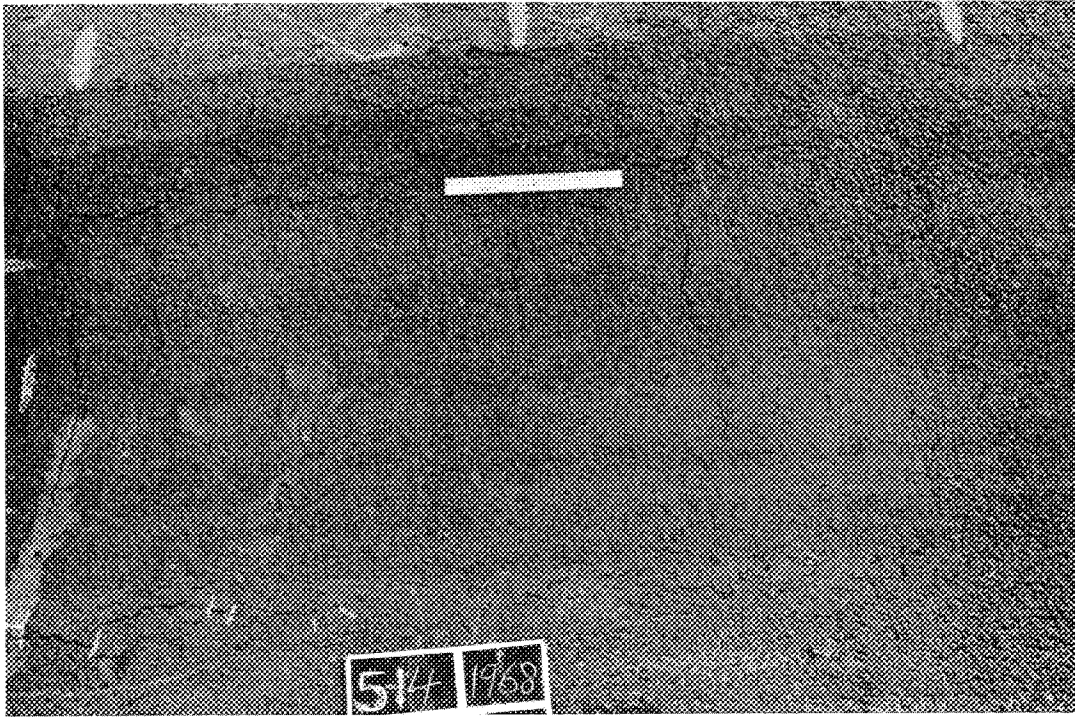
FIGURE 34. CONTINUED DETERIORATION OF SECTION 9 AFTER 740,279 WHEEL LOAD APPLICATIONS ON MAY 14, 1968.

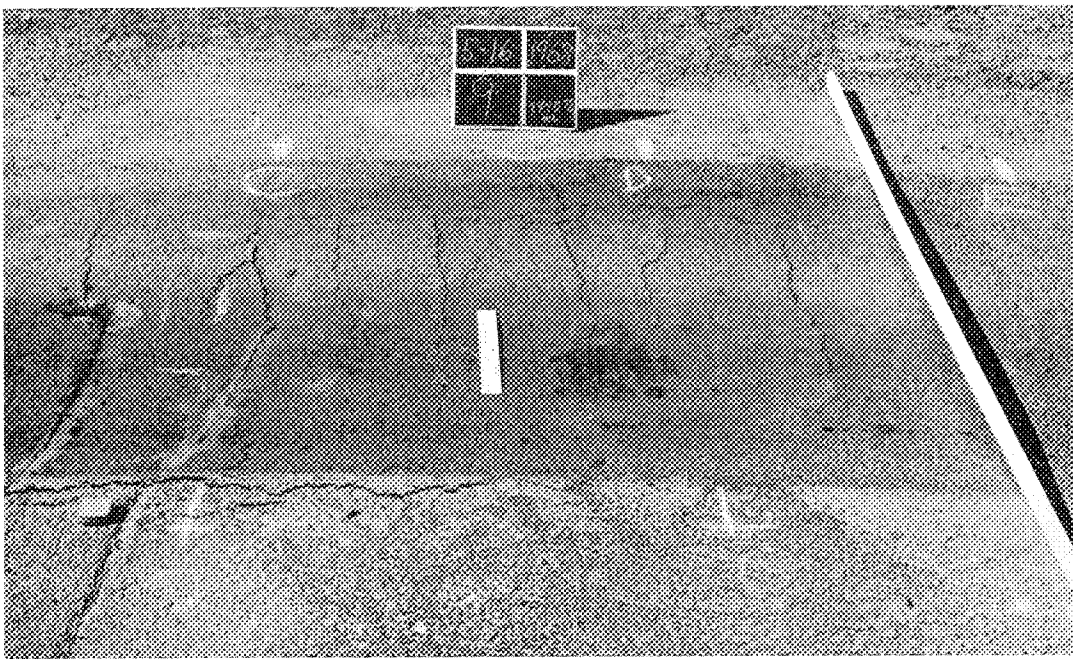
FIGURE 35. CONTINUED DETERIORATION OF SECTION 9 AFTER 744,072 WHEEL LOAD APPLICATIONS, MAY 16, 1968. NOTE THE PERMANENT SETTLEMENT.

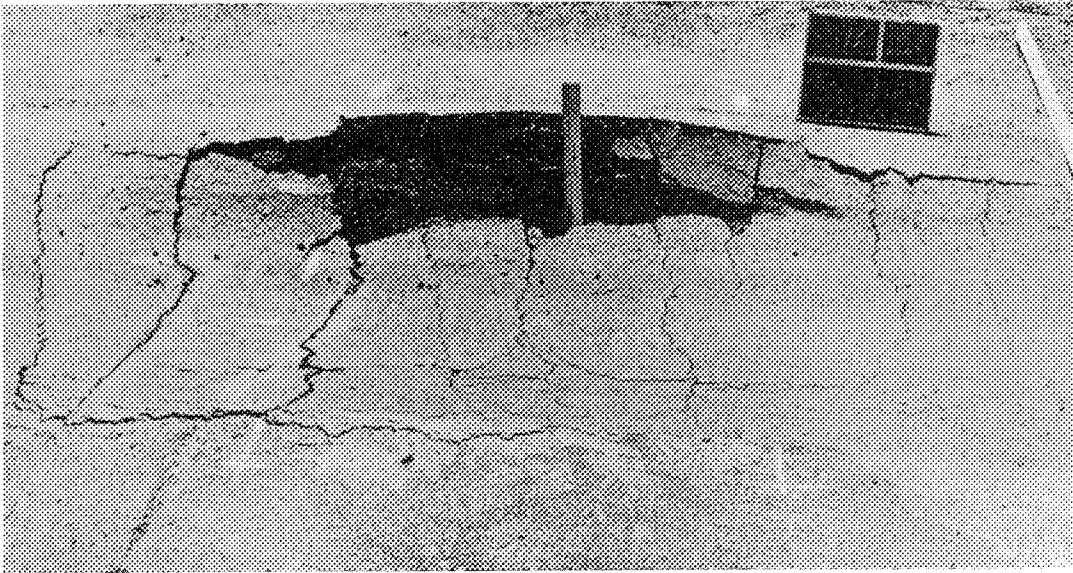
FIGURE 36. "ULTIMATE" FAILURE OF SECTION 9 AFTER 744,723 WHEEL LOAD APPLICATIONS ON MAY 16, 1968.

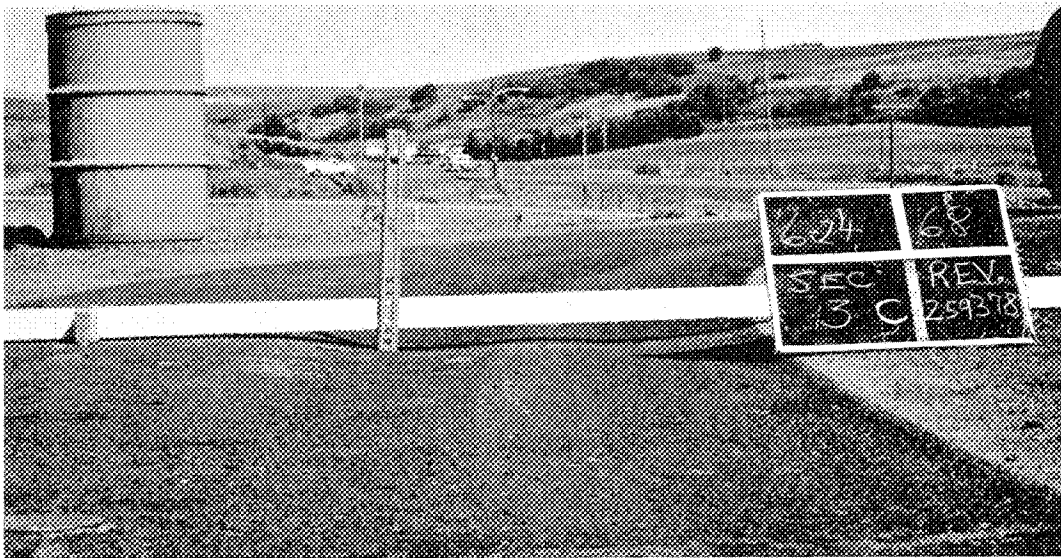
FIGURE 37. PERMANENT SETTLEMENT OF PAVEMENT IN SECTION 3 (3.5 INCHES OF ATB) AFTER 778,134 WHEEL LOAD APPLICATIONS ON JUNE 24, 1968.

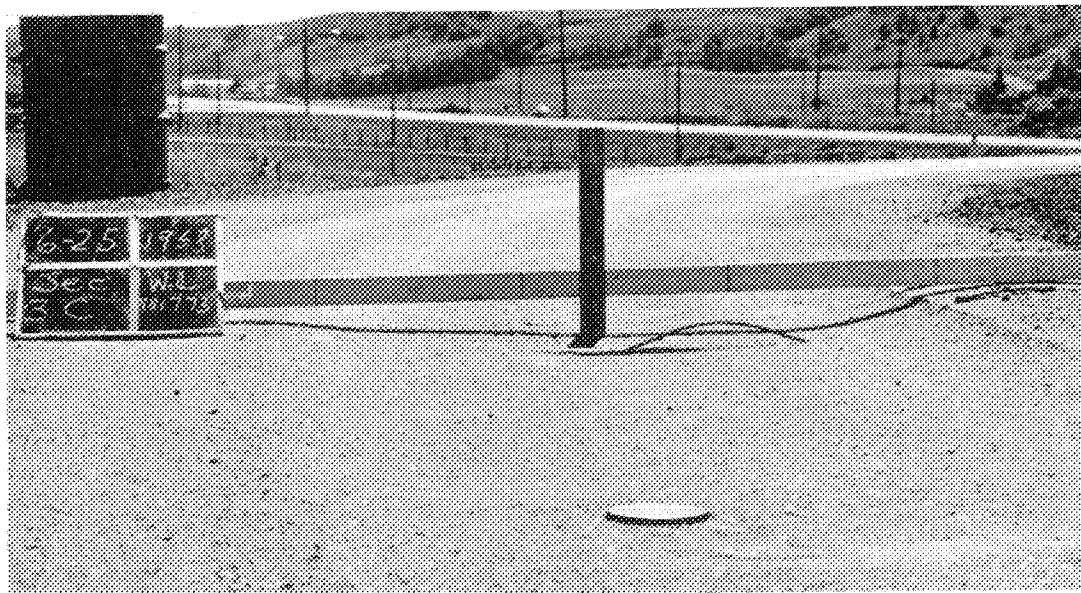
FIGURE 39. CONTINUED SETTLEMENT AND DETERIORATION OF SECTION 3
AFTER 781,773 WHEEL LOAD APPLICATIONS, JUNE 25, 1968.

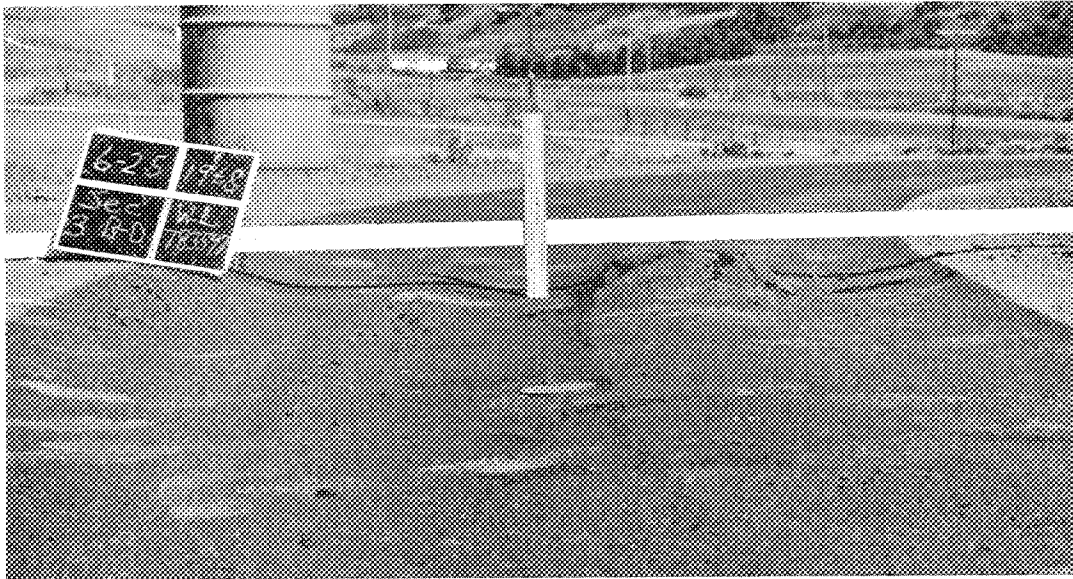
FIGURE 40. "ULTIMATE" FAILURE OF SECTION 3 AFTER 783,597 WHEEL LOADS ON JUNE 25, 1968.

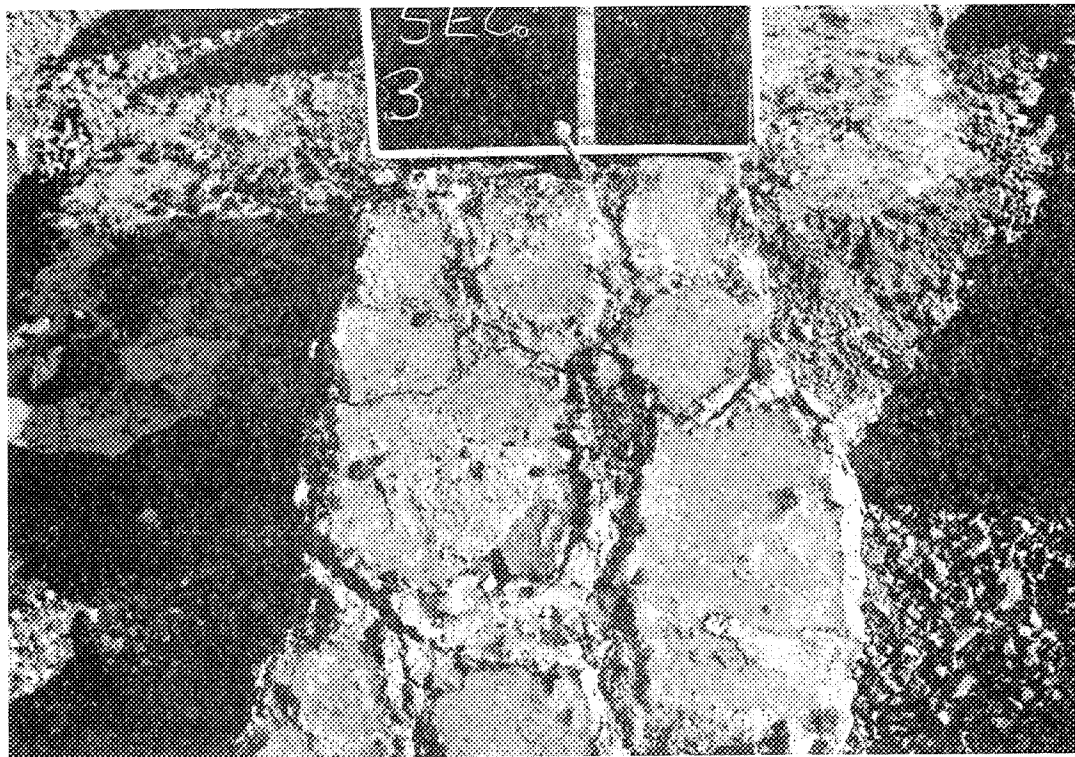
FIGURE 41. THE APPEARANCE OF THE BOTTOM OF SECTION 3 ASPHALT TREATED BASE. NOTE THE FATIGUE CRACKING APPEARANCE AND THE FILLING OF THE CRACKS BY THE SILT SUBGRADE.

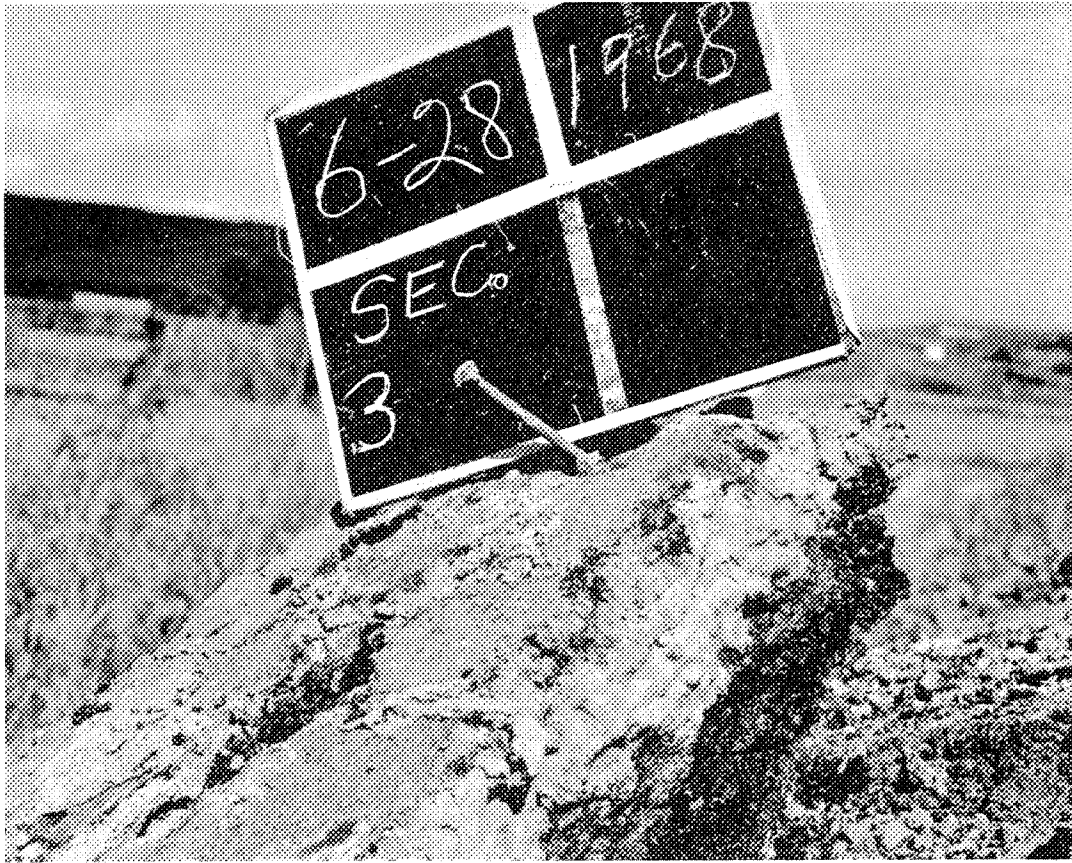
FIGURE 42. SAME MATERIAL AS SHOWN IN PREVIOUS PHOTOGRAPHS. NOTE THE FATIGUE CRACK JOINTS FILLED WITH THE SILT SUBGRADE.

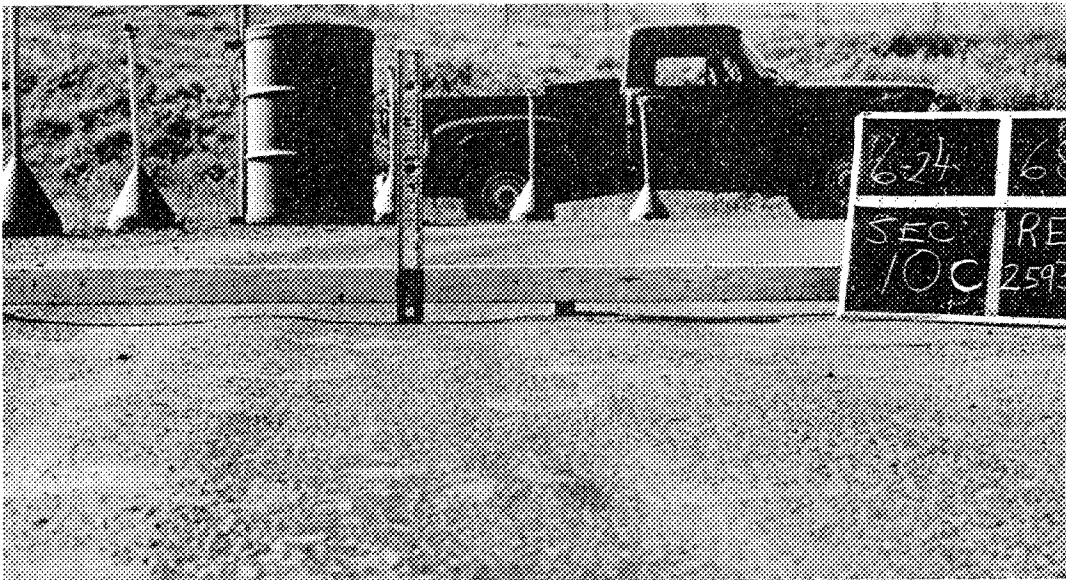
FIGURE 43. RUTTING AND SETTLEMENT IN SECTION 10 (5.0 INCHES OF ETB) ON JUNE 25, 1968, AFTER 778,134 WHEEL LOAD APPLICATIONS.

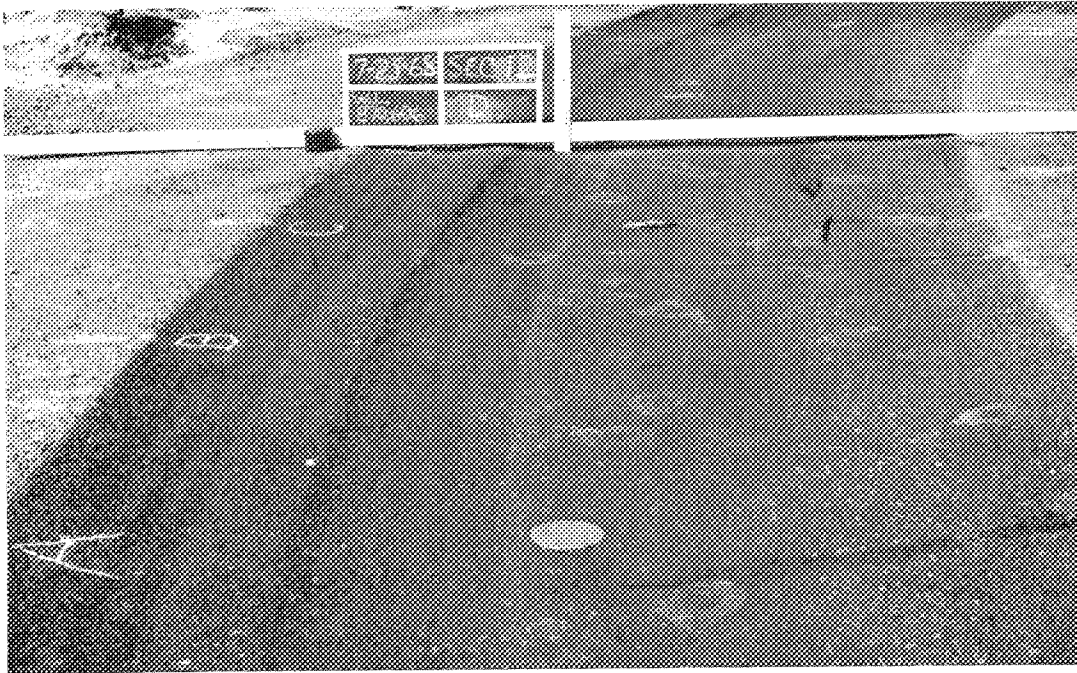
FIGURE 46. FINAL APPEARANCE OF SECTION 12 (9.0 INCHES OF ETB) AFTER 870,606 WHEEL LOADS ON JULY 25, 1968. NOTE THE PERMANENT SETTLEMENT AND THE RUTTING.

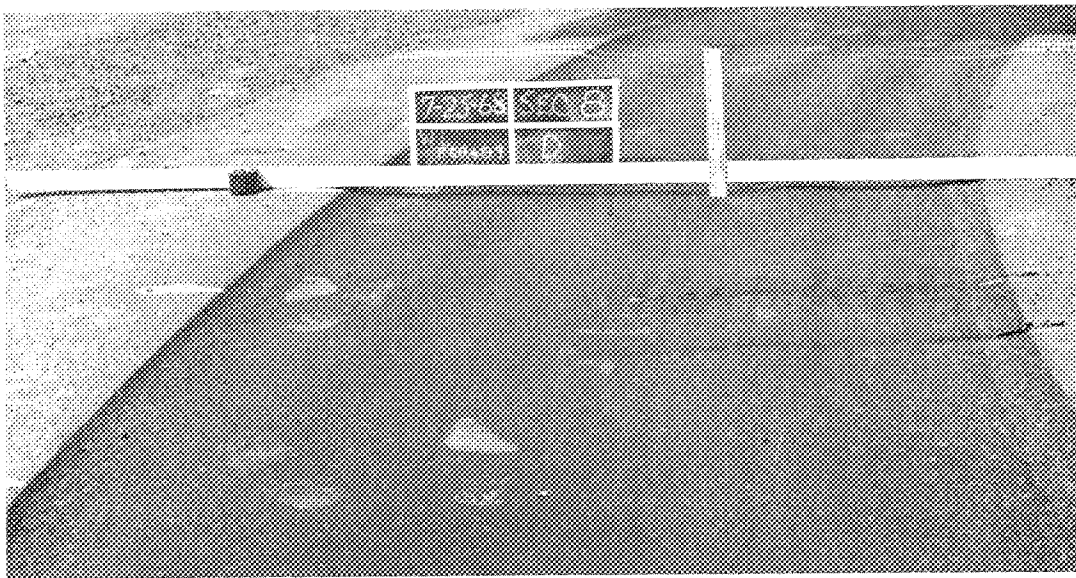
FIGURE 47. FINAL APPEARANCE OF SECTION 8 (12.0 INCHES OF UTB) AFTER 868,689 WHEEL LOADS ON JULY 25, 1968. NOTE THE RUTTING AND PERMANENT SETTLEMENT. THE TRANSVERSE CRACKS FROM LAST FALL HAD HEALED OVER.

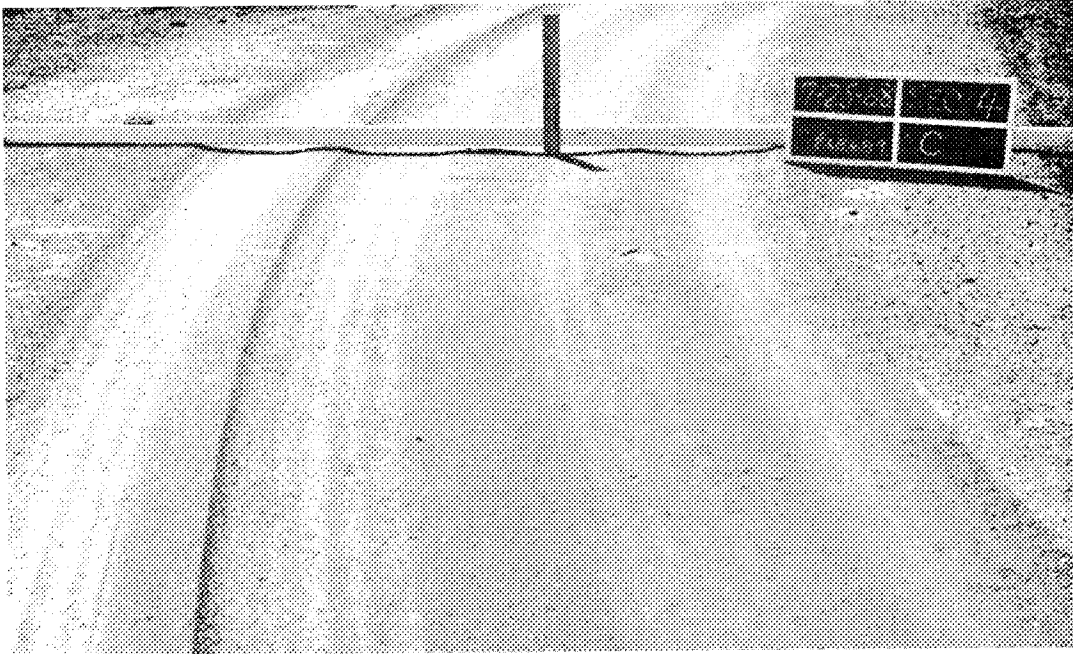
FIGURE 48. APPEARANCE OF SECTION 4 (5.0 INCHES OF ATB) AFTER 868,689 WHEEL LOAD REPETITIONS, JULY 25, 1968. NOTE THE RUTTING AND PERMANENT SETTLEMENT.

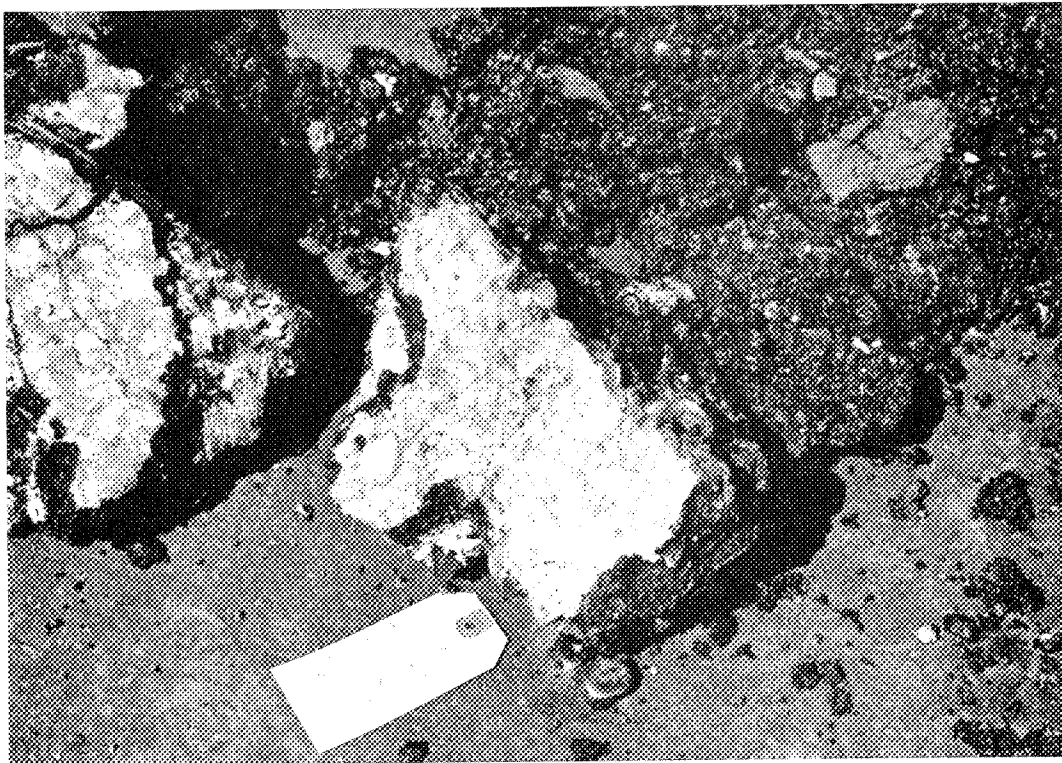
FIGURE 49. APPEARANCE OF THE 5.0 INCH ASPHALT TREATED BASE EXCAVATED FROM SECTION 4. NOTE THE FINE ALLIGATOR CRACKING AT THE BOTTOM OF THE BASE DUE TO FATIGUE CRACKING.

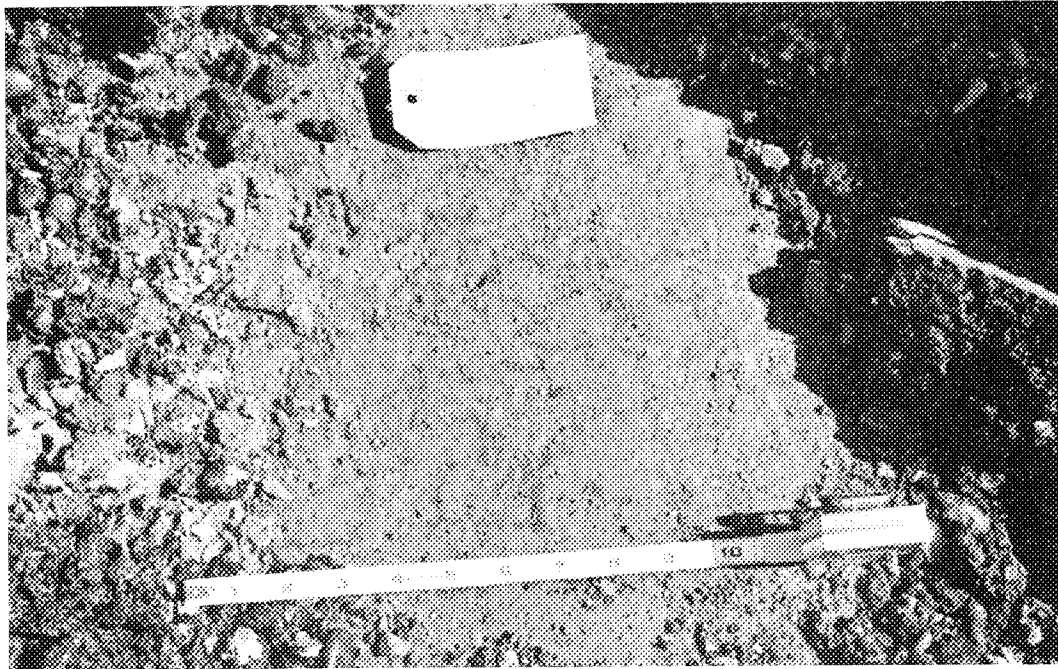
FIGURE 50. APPEARANCE OF THE SUBGRADE AFTER THE BASE IN SECTION 4 WAS REMOVED. NOTE SUPER-IMPOSITION OF FATIGUE CRACKING PATTERN ON THE SUBGRADE.
